CASE STUDY

Low Energy Whole House Refurbishment

Mid-terraced house, Doncaster

A low cost 'whole house' low energy refurbishment - 1890's Victorian mid terrace to current energy standards.

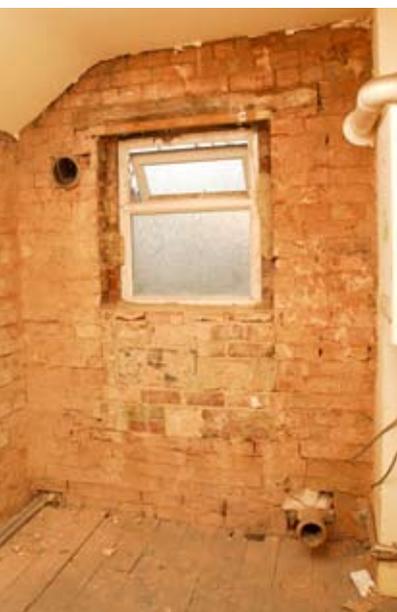
Fig 1

Figure 1 shows Stage 1 with all fixtures removed and the plaster removed back to the original 225mm thick brickwork, although in most cases the Polystuds would be affixed through the existing plasterwork.

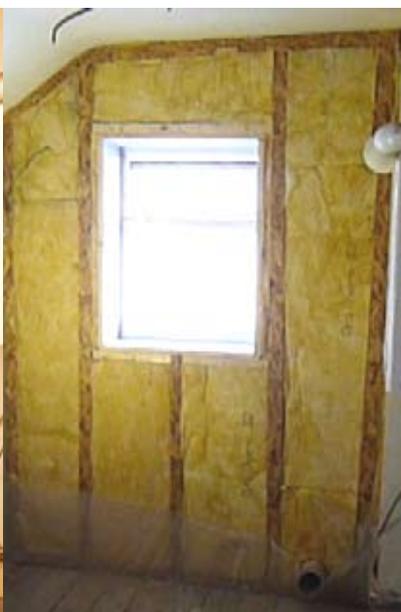
Fig 2

Figure 2 shows Stage 2 with the new Polystud mechanically fixed to the brick wall and 75mm of DriTherm IWI Slab friction fitted between to ensure a complete coverage of insulation across the whole wall.

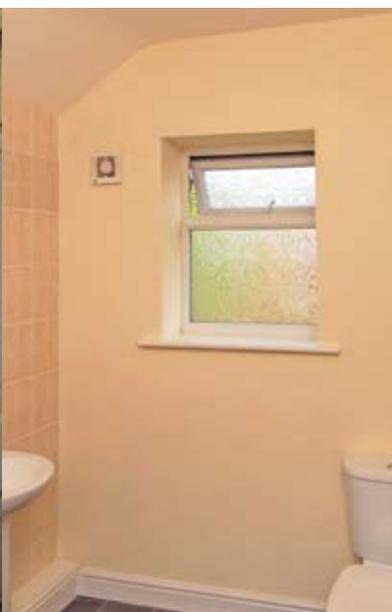
Fig 3

Figures 3 and 6 show Stage 3 with the 12.5mm vapour check plasterboard fixed to the Polystud framework in the bathroom and the living room. The overall reduction in floor area was less than 2 per cent.

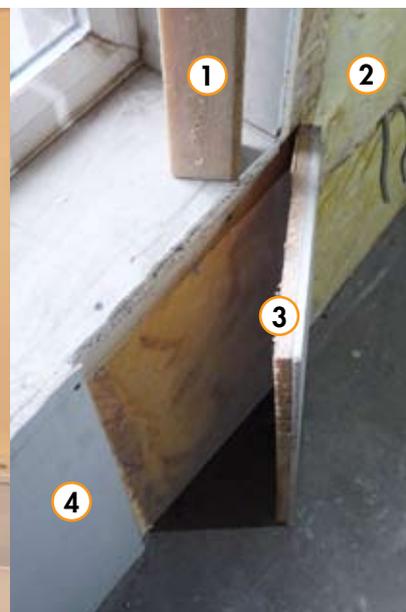
Fig 4

THE SYSTEM (fig 4)

1) Polystud which has an overall size of 50mm wide x 75mm deep x 2400mm long to replace a typical size of timber stud. This comprises Polyfoam extruded polystyrene laminated to Oriented Strand Board (OSB). Polystuds were mechanically fixed to the wall with the OSB facing into the room using 130mm screws and plugs, a minimum 40mm fixing penetration into the wall is required.

2) 75mm thick DriTherm IWI water repellent glass mineral wool slab with a

thermal conductivity of 0.032 W/mK friction fitted between the Polystuds to ensure intimate contact between the inside of the wall and the back of the plasterboard thereby preventing unwanted air movement and draughts through the system.

3) 27mm Polyfoam Linerboard, a laminate of 17.5mm Polyfoam extruded polystyrene and 9.5mm Knauf plasterboard fitted around all window and door reveals to limit cold bridging and surface condensation. 27mm Polyfoam Linerboard was also installed at all party wall junctions to a minimum width of 400mm and the full height of the rooms in order to prevent heat loss and the potential for condensation and mould growth in internal corners.

4) 12.5mm vapour check plasterboard attached to the OSB of the Polystuds using 25mm drywall screws with all edges sealed with Knauf Multi Purpose Sealant to prevent air movement behind the wall lining reducing the thermal performance of the installed system. Knauf Insulation also used the alternative Knauf metal framing system at the front of the property to assess suitability and timing of the two installations.

Both Polystud and metal systems resulted in an improvement of the U-value from approximately 2.00 W/m²K to 0.35 W/m²K, an improvement in thermal performance of almost 80 per cent

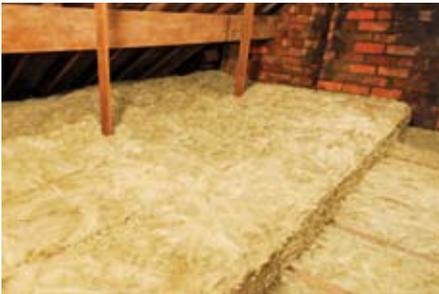
Fig 5

Figure 5 shows the existing 100mm thickness of insulation between the ceiling joists, topped up with a second layer of 200mm Loft Roll.

Illustration, not actual loft

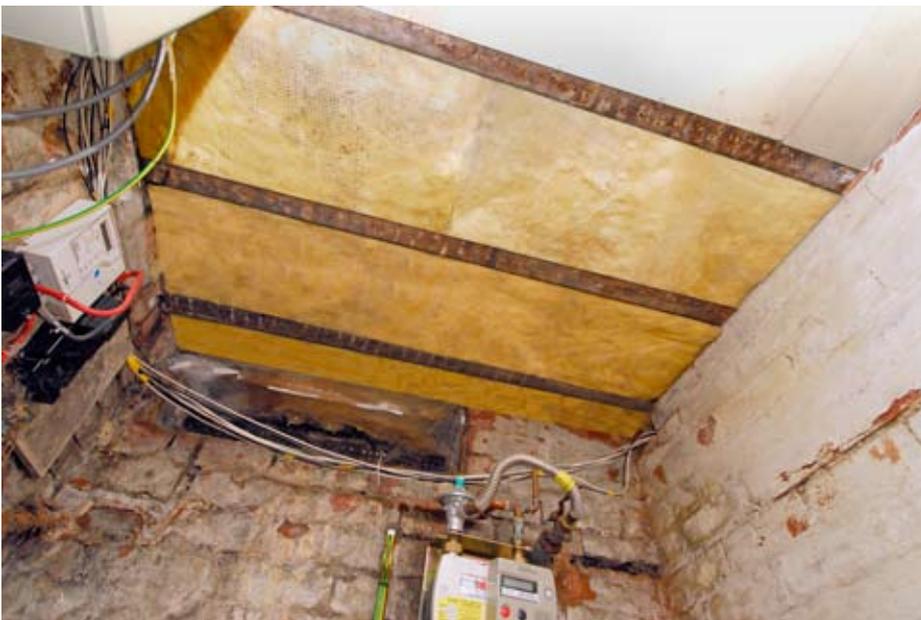
Fig 7

The front of the property had a $\frac{3}{4}$ height cellar above which was the timber floor of the living room. Knauf Insulation took the opportunity of insulating this area from below with

150mm of glass mineral wool friction fitted between the timber floor joists. As the cellar was prone to seasonal flooding, with a high moisture content in the cellar atmosphere, it was decided to use DriTherm IWI water repellent slab in 2 layers of 75mm to fully fill the 150mm deep floor joists and ensure the insulation was in close intimate contact with the underside of the timber floor boards to eliminate air movement. Figure 7 below shows part of the cellar ceiling.

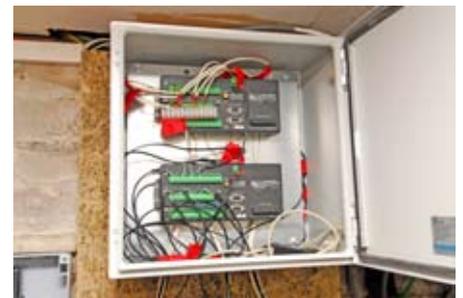
Fig 8

HoBo type sensors were used in each room to measure the internal conditions as well as installing an external HoBo sensor to monitor weather conditions. Figure 8 below shows the set up of the data logger.

In conjunction with University College London, Knauf Insulation have also installed monitoring equipment to enable measuring of the conditions at the interface of the insulation

and internal face of the solid wall. Permanent in-situ sensors have been installed in each room to measure relative humidity and temperature and this data is collected in a logger located in the cellar. University College London will work with Knauf Insulation over coming years to measure and interpret the results generated. Sensors were also positioned within the suspended timber ground floor zone and on the cellar wall.
